Manhole Inspection Summary

Manhole # S35II_011MH

Insp Date: **3/13/07 9:26 AM**

Location Address: **200 LANVALE ST**

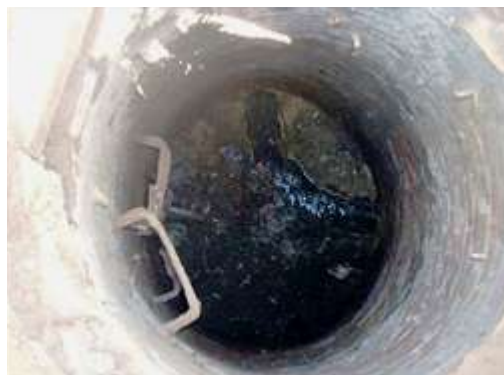
Top View

Corroded and missing steps. Evidence of surcharge - Bench debris. Channel debris.

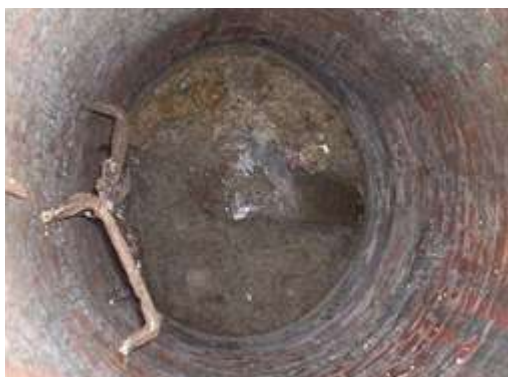
Defect

Active surcharge - 1st visit

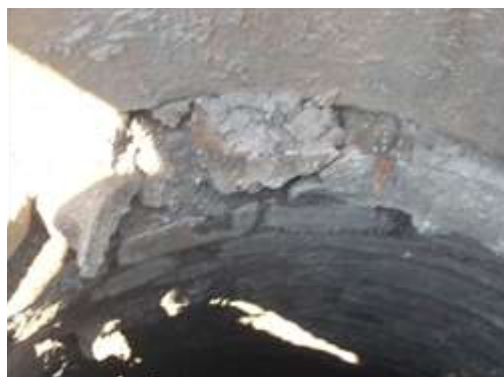
Defect

Frame leaks. Frame offset. Adjustment deterioration, loose brick and infiltration. Corbel and Barrel infiltration.

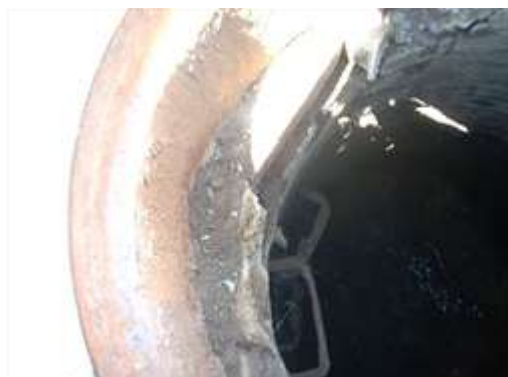
Defect

Frame leaks. Frame offset. Adjustment deterioration, loose brick and infiltration.

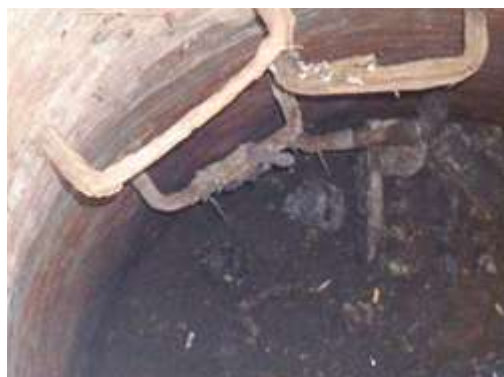
Defect

Corroded steps. Evidence of surcharge - Bench debris.

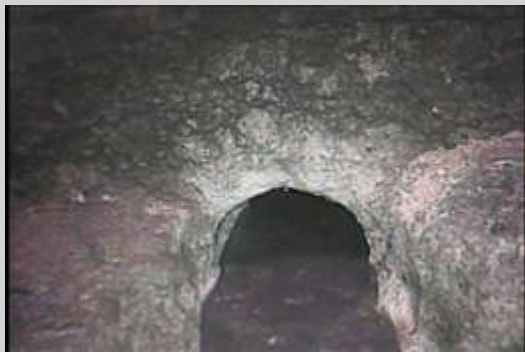
8 in. Circular Gravity Sewer Pipe Out @ 12 O'Clock

Deposits: ☐ None ☒ **Mud** ☐ Sludge ☒ **Debris** ☐ Grease

Silt Depth: **2** (in.) Deposits Extent: **Light**

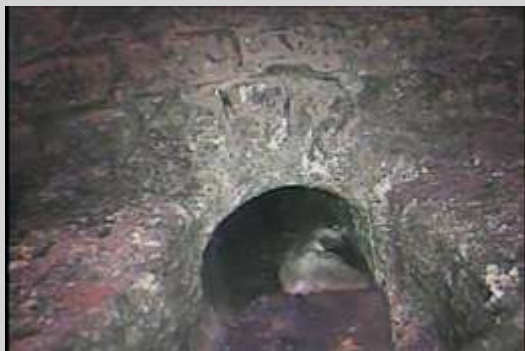
8 in. Circular Gravity Sewer Pipe In @ 3 O'Clock

Barrel deterioration and infiltration.

Deposits: ☐ None ☒ **Mud** ☐ Sludge ☒ **Debris** ☐ Grease

Silt Depth: **1** (in.) Deposits Extent: **Light**
